Manhole Inspection Summary

Manhole # S21K__046MH

Insp Date: **9/26/07 11:37 AM**

Location Address: **127 FULTON AVE**

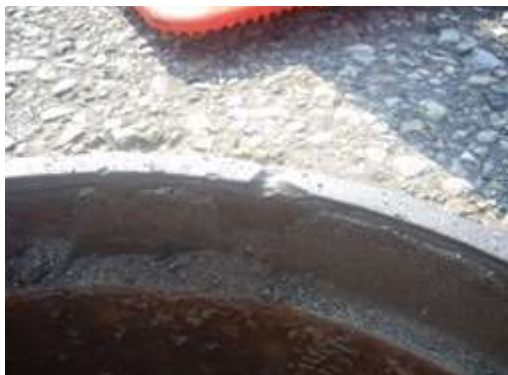
Frame Offset: **2** (in.) Condition: ☒ Sound ☐ Cracked ☐ Leaks

worn frame

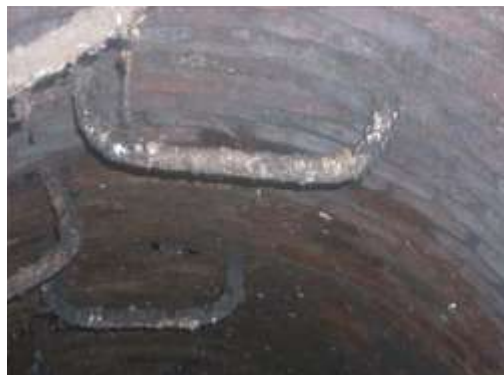
Defect 6

Surcharge ☒ **Evidence Of Surcharge** Depth: **6** (ft.) ☐ Active Surcharge Present

SURCHARGE EVIDENCE ON THE STEPS

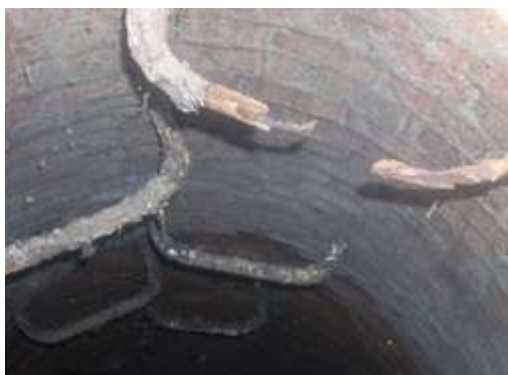
Defect 5

Steps Count: **5** Missing: **1** ☒ **Corroded**

CORRODED AND MISSING STEPS

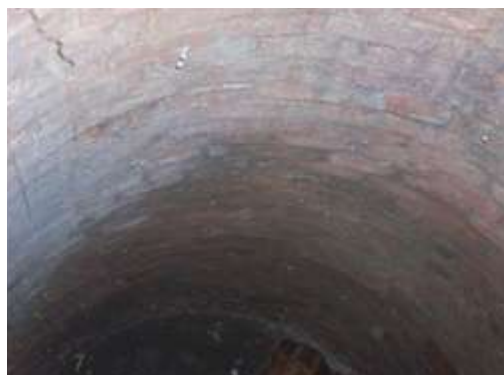
Defect 4

Infiltration: ☐ None ☐ Joint ☐ Cracks ☐ Mortar ☐ Roots ☒ **Wall**

INFILTRATION OF THE CORBEL WALL

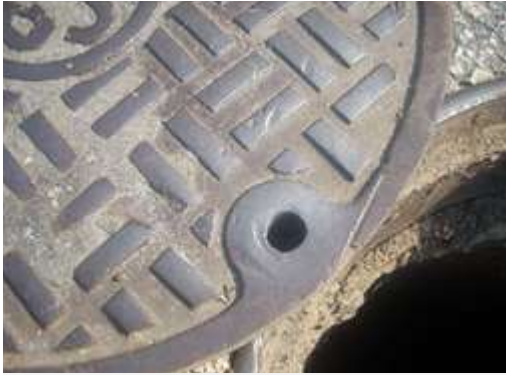
Defect 3

Type: **Sanitary** Condition: **Worn** Cover Material: **Cast Iron**

WORN COVER

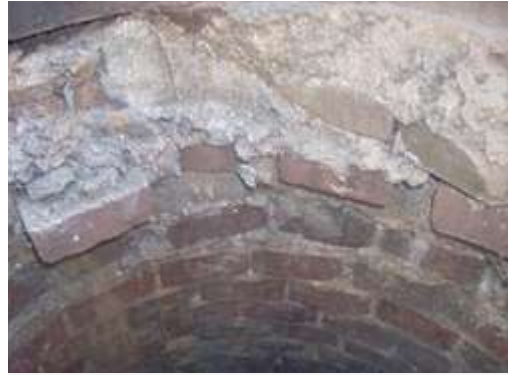
Defect 2

Condition: ☐ Sound ☐ Cracked ☐ Root Intrusion ☒ **Loose Brick** ☒ **Deteriorated**

DETERIORATED CHIMNEY WITH
LOOSE BRICKS

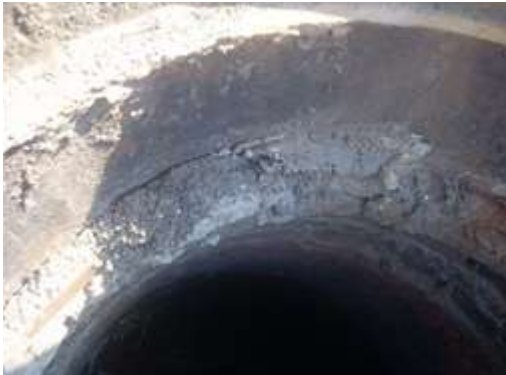
Defect 1

FRAME OFFSET

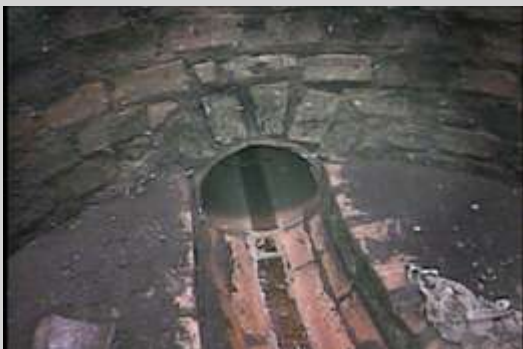
8 O'Clock Inflow

Pipe Height: **8.4** (in.) Rod and Bar (Angled)
Pipe Material: **Clay** ☐ Pipe Lined
Invert Depth: **10.23** (ft.) Flow Characteristics: **Slow**
Deposits: ☒ None ☐ Mud ☐ Sludge ☐ Debris ☐ Grease
Silt Depth: (in.) Deposits Extent:
Infiltration: **None** Pipe Seal Cond: **Broken**
